Lab Test Report

Fall Protection Distributors LLC
Howie Scarboro

12/12/2014

Received three pieces for Salt Fog testing.

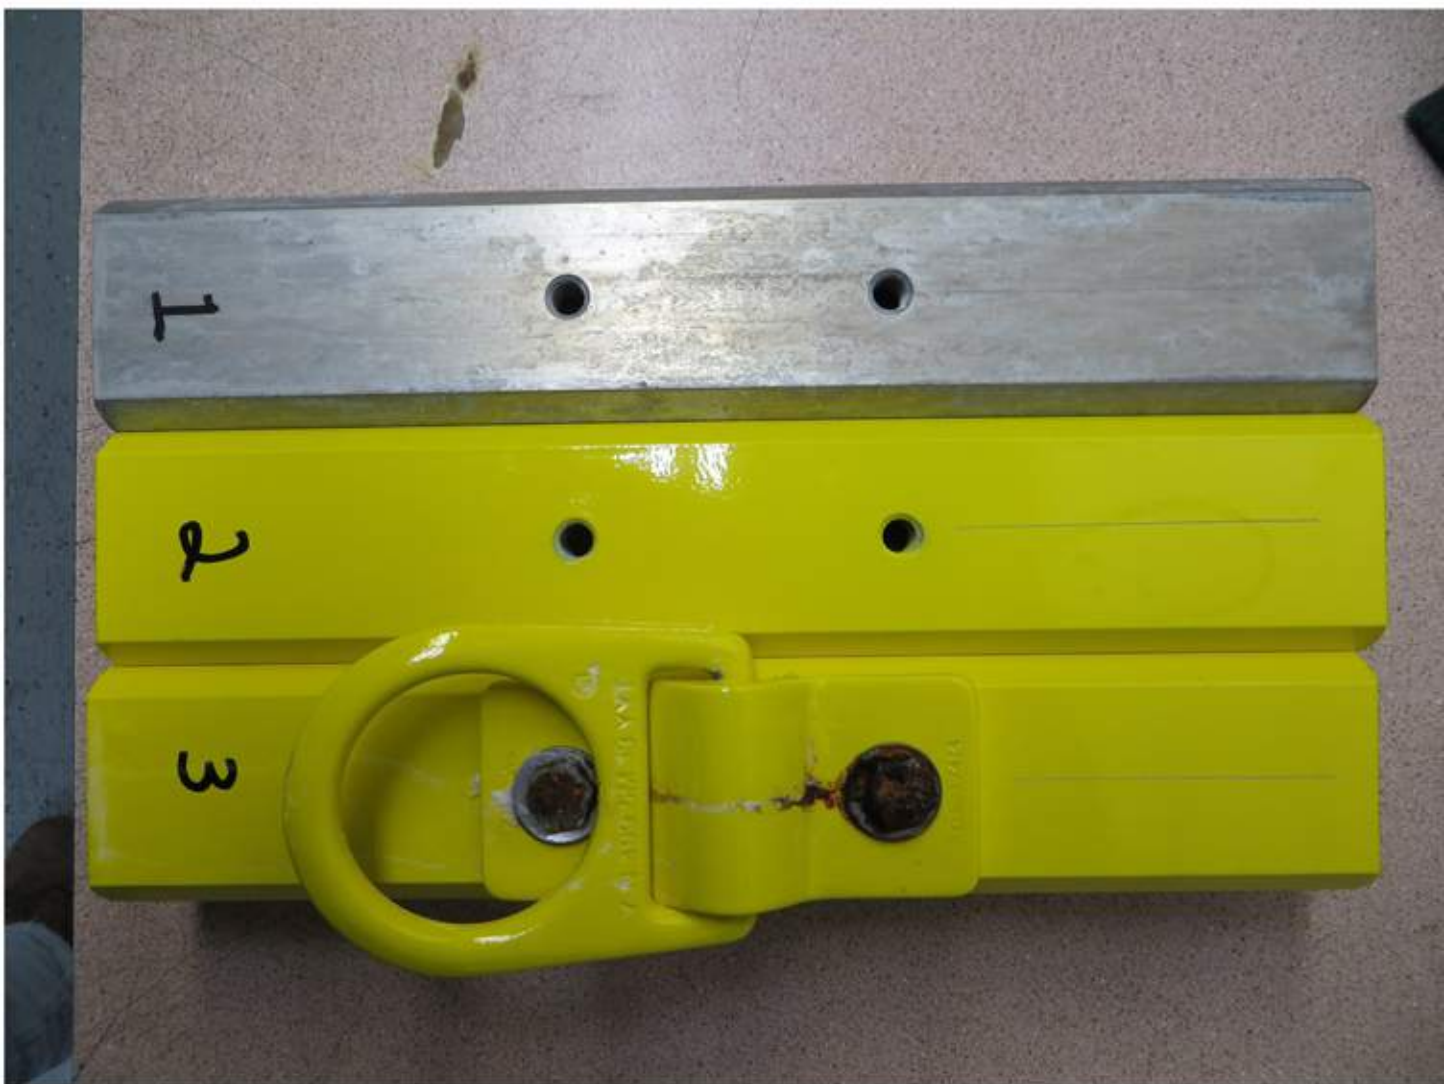
Pc. 1: Bare aluminum was corroded.

Pc. 2: Scribe through powdercoating had no creepage. It looked the same as when it went into testing.

Pc. 3: Scribe through powdercoating had no creepage. The brass ring had no failure. The galvanized bolt heads showed white corrosion and red rust. This is due to zinc galvanizing's inability to protect in an accelerated corrosive environment.
