## **PERFORMANCE TEST REPORT**

**FALL PROTECTION DISTRIBUTORS, LLC**

**PRODUCTS: Spanner Plate and Adapter Plate**

**Report No.: F6078.01-106-31**

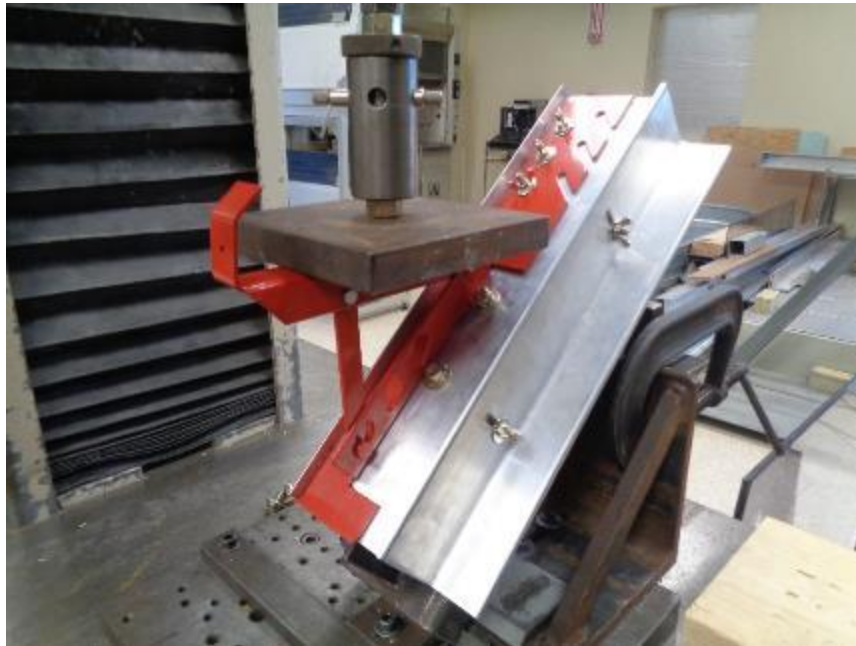
**Photo No. 1**  
**Adapter Plate Test - Roof Bracket (No Clamp) - Pre-Test Condition**

Adapter plate assemblies were attached to mock standing seam roof section on a 45° angle to simulate a 12-12 pitch. Specimens were individually secured to the base of a Satec Model MII 50 UD Universal Test Machine (ICN: Y002011) and loaded at a computer controlled rate of 0.50 in/min until failure was achieved.

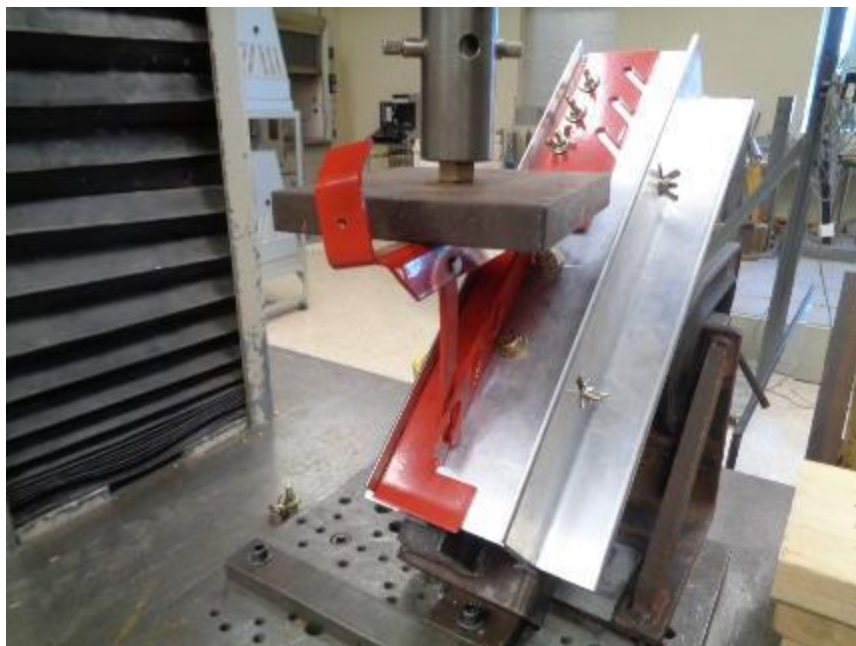
**Photo No. 2**  
**Adapter Plate Test - Roof Bracket (No Clamp) - Post Test Condition**

Sample Description		Maximum Load (lbf)	Deflection at Max Load (in)	Load at Yield (lbf)
Specimen No	Clamped			
1	Yes	4,228	0.292	4,228
2	No	2,980	0.313	2,980
3	Yes	3,314	0.312	3,314
4	No	3,307	0.391	3,307
5	Yes	3,508	0.395	3,508
6	No	2,970	0.286	2,970
7	Yes	3,405	0.350	3,321
Mean		3,387	0.334	3,375

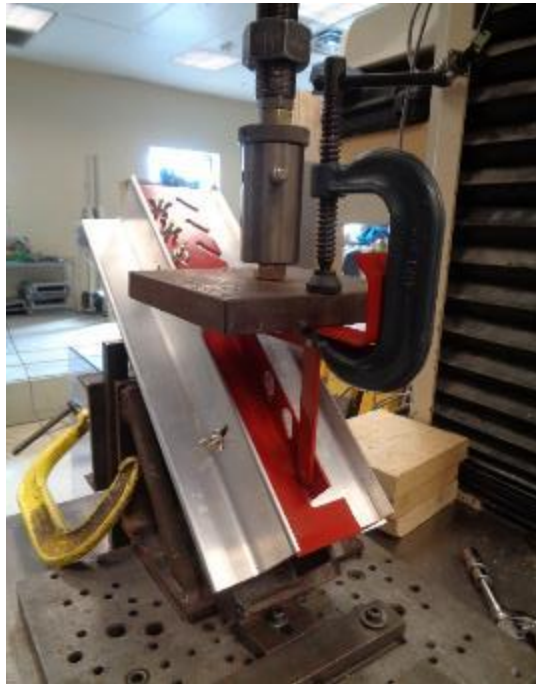
**Photo No. 3**  
**Adapter Plate Test - Roof Bracket (with Clamp) - Pre-Test Condition**

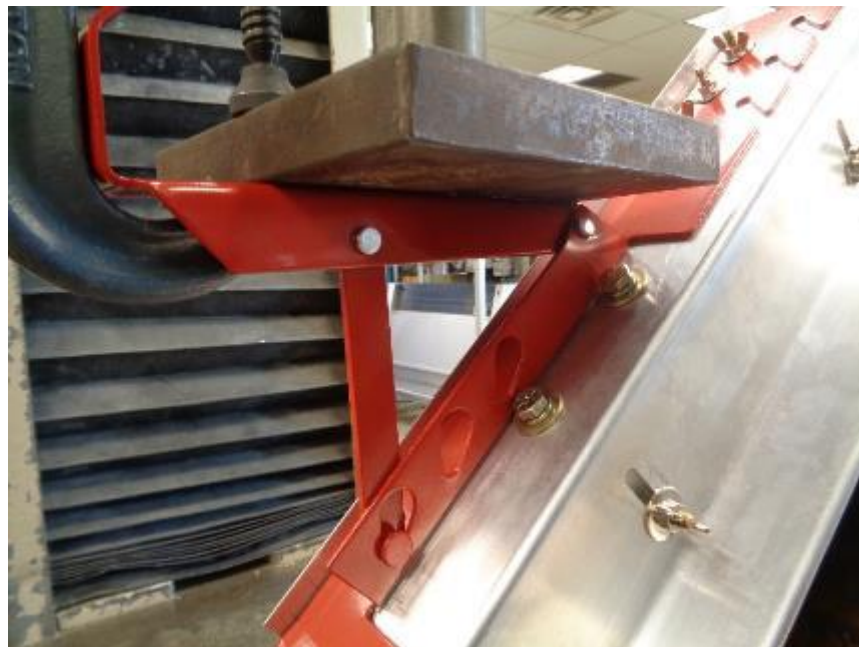
**Photo No. 4**  
**Adapter Plate Test - Roof Bracket (with Clamp) - Post Test Condition**

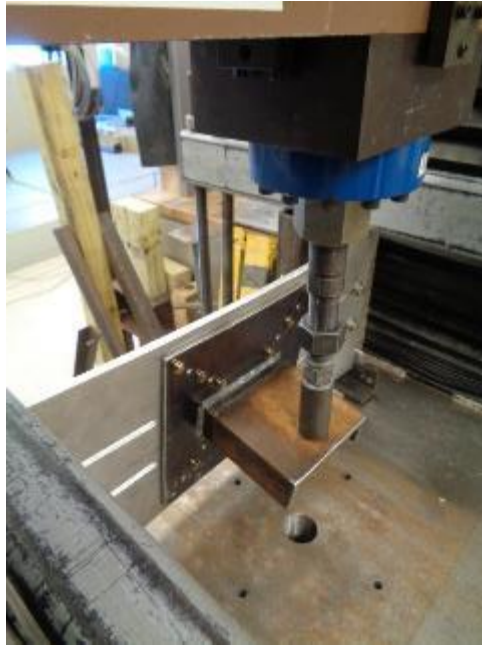
**Photo No. 5**  
**Spanner Plate Loading Test Set-Up**

Spanner plates and anchors were attached vertically to a mock roof section consisting of two standing seam roof seams. Specimens were individually secured to the base of a Satec Model MII 50 UD Universal Test Machine (ICN: Y002011) and loaded at a computer controlled rate of 0.25 in/min to specific load intervals. Spanner plate deflection was measured at a pre-determined peak load and also when the load is released to document permanent set conditions. All specimens were then loaded until failure was achieved.

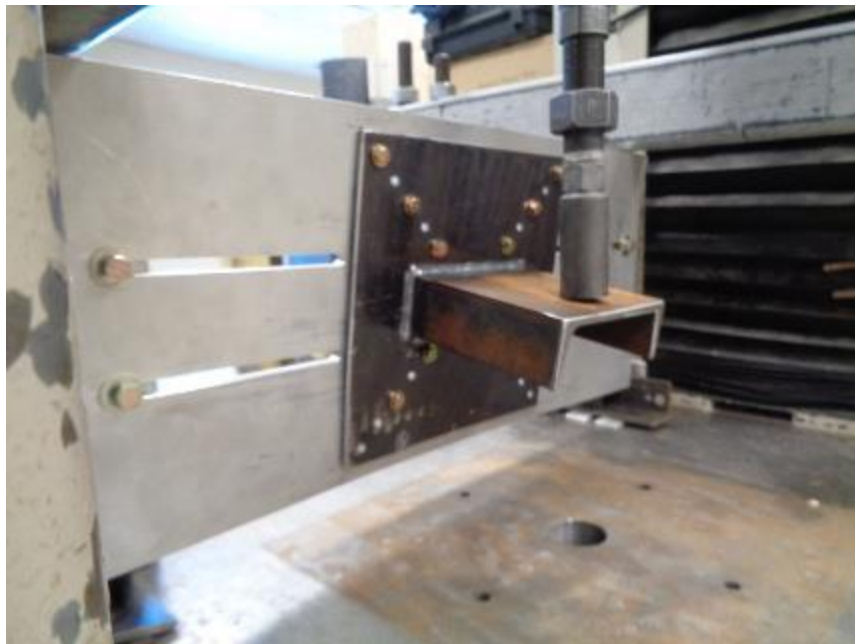
**Photo No. 6**  
**Spanner Plate Loading Test in Progress**

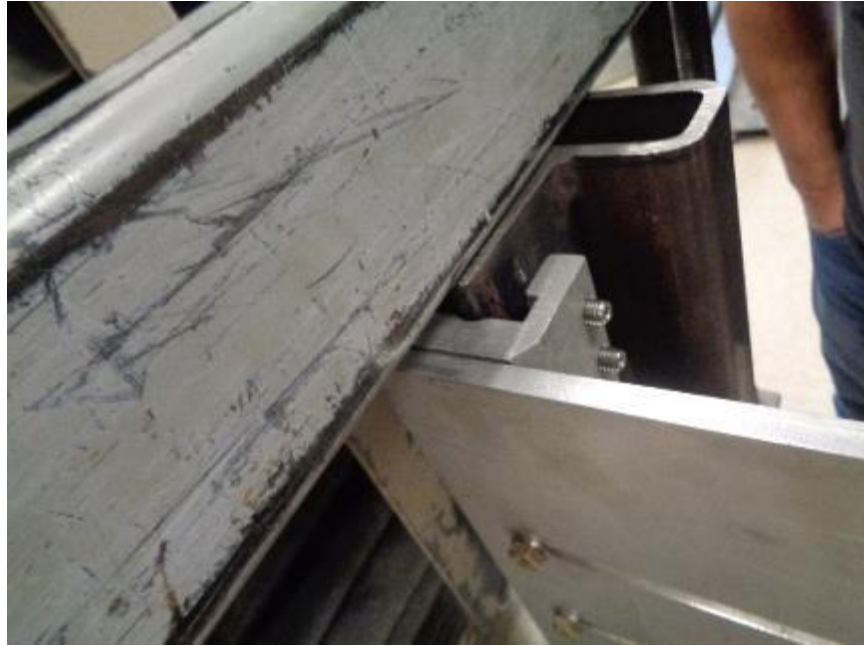
**Photo No. 7**  
**Spanner Plate Deflection - 3600 lbf Applied Load**

Specimen No	Load Interval (lbf)	Hold Time (min)	Maximum Load (lbf)	Deflection (in)	Permanent Set (in)
1	3600	2	3,610	0.515	None
	5000	1	5,010	0.690	0.065
	Load to Failure		10,000	2.183	N/A
2	3600	2	3,610	0.514	None
	5000	1	5,010	0.743	1.04
	Load to Failure		10,700	2.862	N/A
3	3600	2	3,610	0.368	None
	5000	1	5,020	0.498	0.071
	Load to Failure		12,400	3.523	N/A

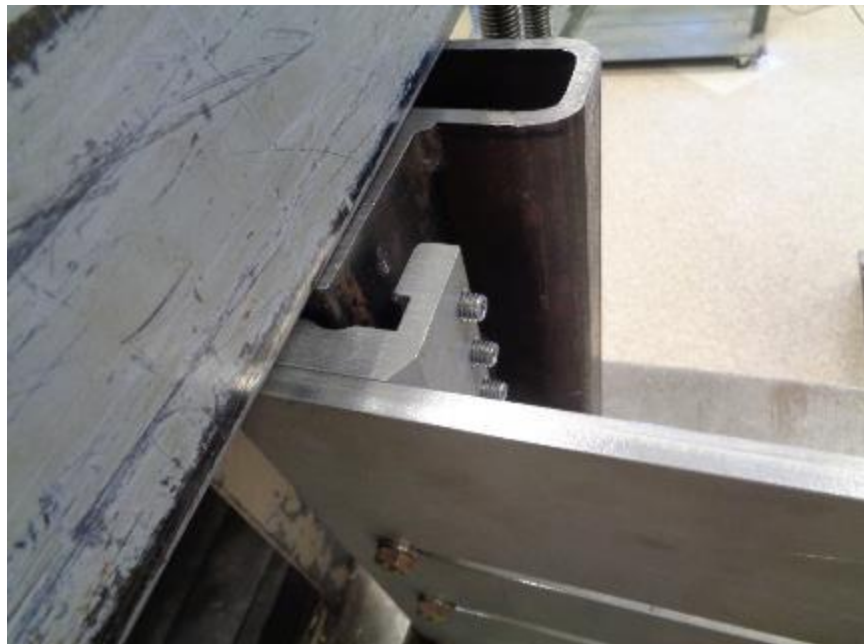
**Photo No. 8**  
**Spanner Plate Deflection - 3600 lbf Load Released**

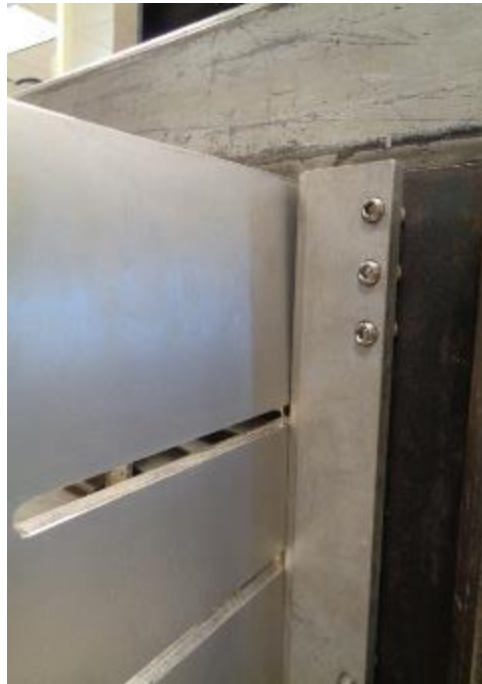
**Photo No. 9**  
**Spanner Plate Deflection - 5000 lbf Applied Load**

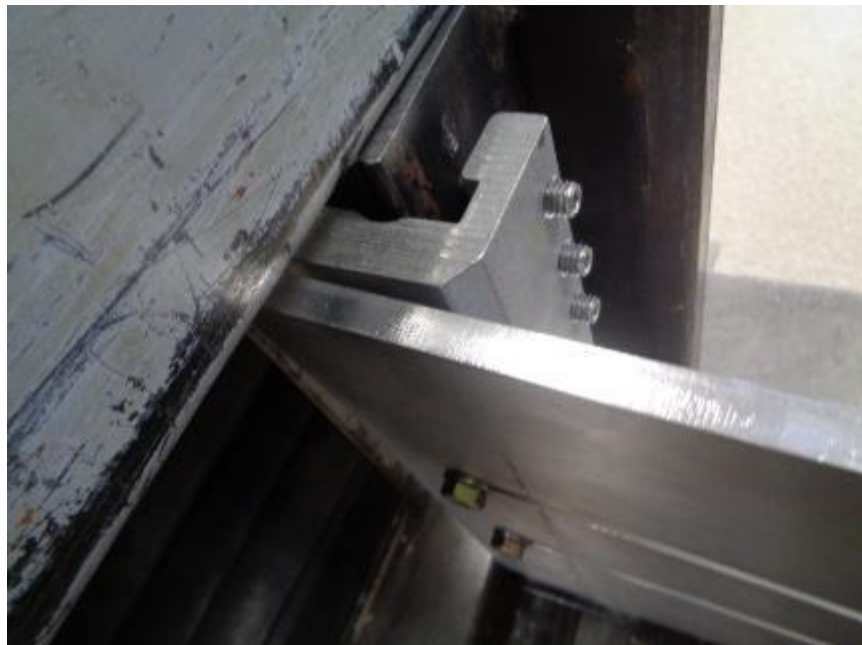
**Photo No. 10**  
**Spanner Plate Deflection - 5000 lbf Load Released**

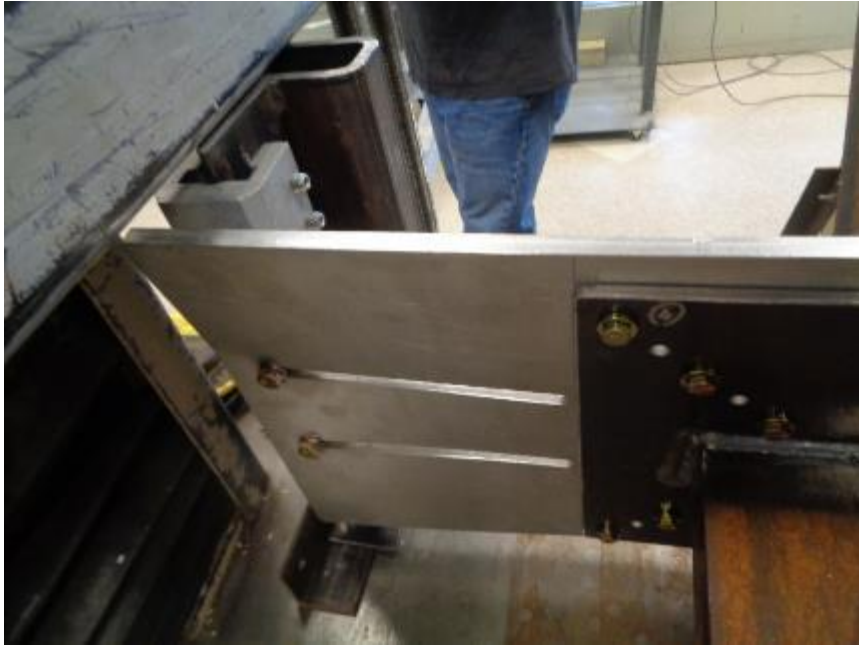
**Photo No. 11**  
**Spanner Plate Failure Test in Progress**

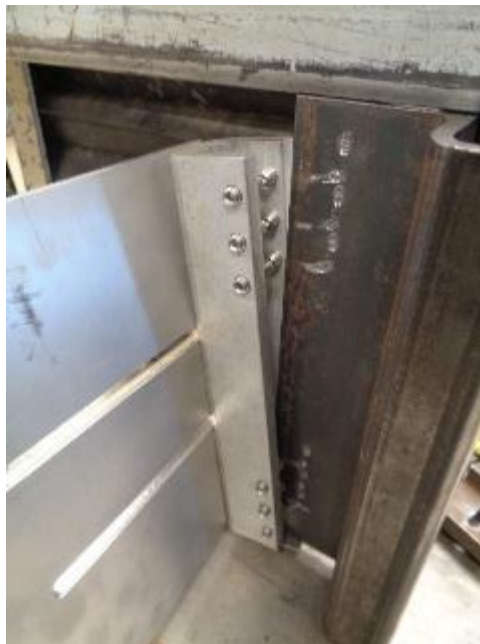
**Photo No. 12**  
**Spanner Plate Failure Test - Anchor Failure**
