FALL PROTECTION DISTRIBUTORS, LLC TEST REPORT

OSHA 1910.140 STATIC STRENGTH EVALUATION OF A STANDING SEAM BRACKET SYSTEM (SSRA1)

I6764.01-106-31 R0

Product: SSRA1 Anchorage Bracket - Standing Seam Fall Protection Anchorage System

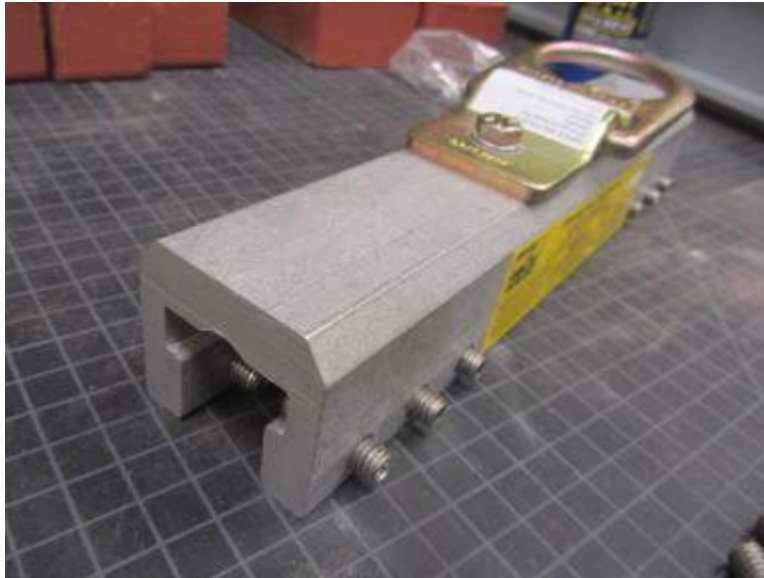
Photo No. 1
Pretest Condition SSRA1 Bracket Anchorage Detail

Note 1 - Aluminum bracket w/attached steel D-ring affixed to 24 ga coated steel seamed roofing using 12 nylon tipped, stainless steel tension bolts. The seamed roofing panels were mounted to nominal 2x lumber using 3/4", 1" washer head screws.

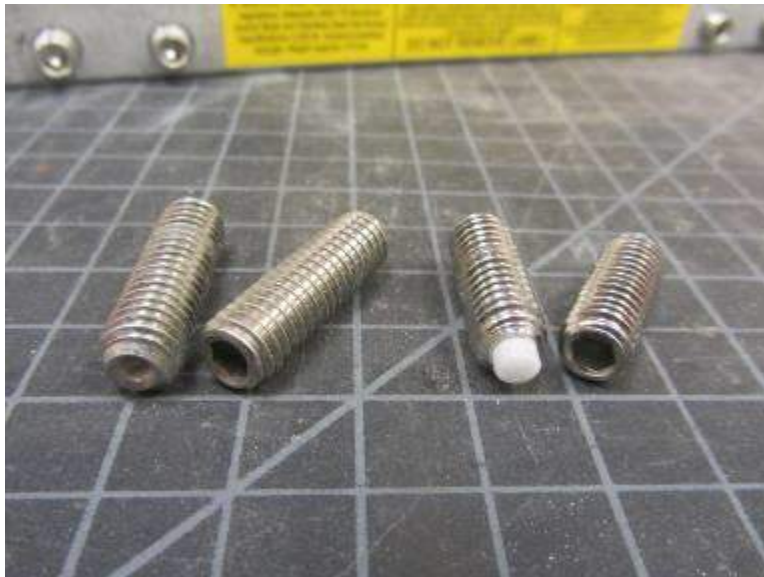
Photo No. 2
Pretest Condition Cupped Tip (Left) and Nylon Tip (Right) Tensions Bolt Details

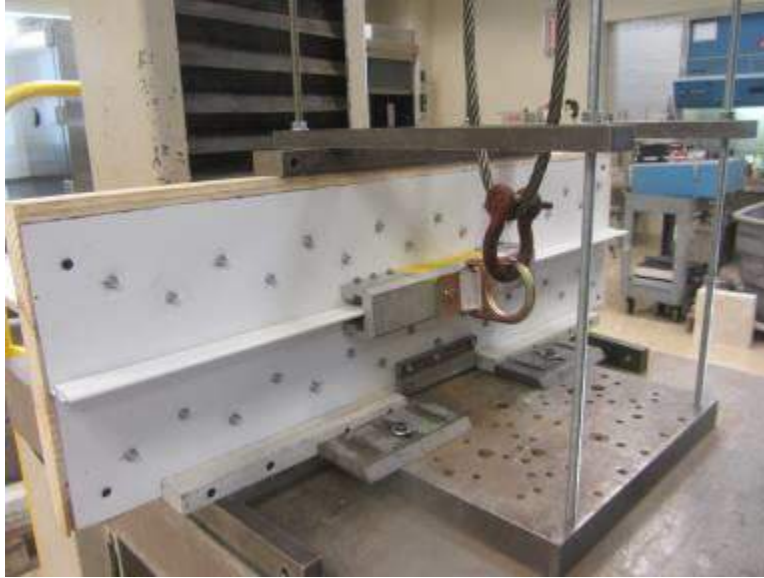
Photo No. 3

OSHA 1901.140(c)(8) Static Load Evaluation - Perpendicular to Seam Test Setup

The Static Strength evaluation was performed on a SATEC UTM (ICN: Y002011). Load was applied both parallel and perpendicular (90°) to a standing seam on a roofing mockup assembly. A total of 3 installation mockups were evaluated for each of the two conditions using detailed loading orientations for nylon tip tension bolts at 180 ft-lbs torque. Load was applied to the attached anchorage through an integrated D-Ring component at a constant rate of 2 in/min. until the target load of 3,600 lb_f was achieved and then held for a minimum of 1 minute prior to release and evaluation of the post-test mockup assembly. Test results were evaluated against the performance requirement of minimum 3,600 pounds tensile pounds force without failure or permanent deformation.

SPECIMEN DETAILS				PEAK LOAD (lb _f)	3,600 lb _f HOLD DURATION (min)
NO.	LOAD DIRECTION	ANCHORAGE SYSTEM	TORQUE (ft-lbs)		
B-1	In-Line Load (Perpendicular to Seam)	Nylon Tip	180	3,694	1
B-2				3,656	1
B-3				3,658	1
Average				3,669	1

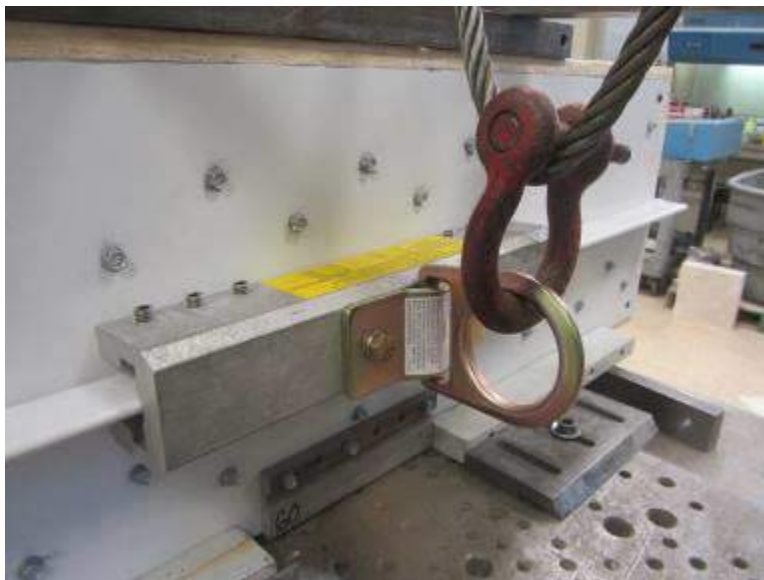
Photo No. 4

OSHA 1901.140(c)(8) Static Load Evaluation - Perpendicular Load Application Detail

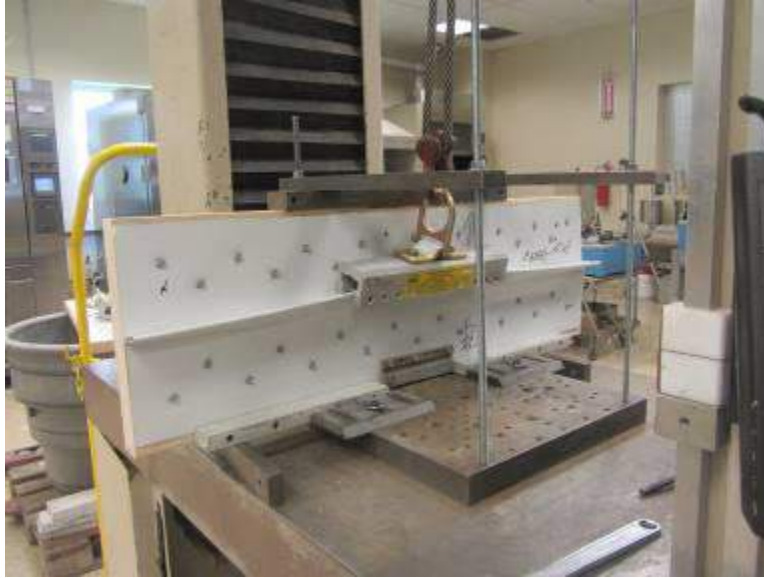
Photo No. 5

OSHA 1901.140(c)(8) Static Load Evaluation - Perpendicular Load Test End Condition

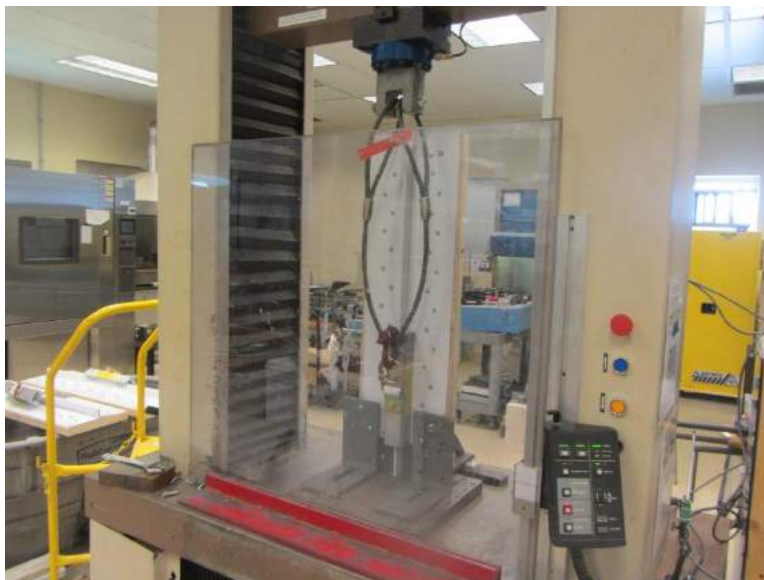
Photo No. 6

OSHA 1901.140(c)(8) Static Load Evaluation - Parallel to Seam Test Setup

SPECIMEN DETAILS				PEAK LOAD (lb _f)	3,600 lb _f HOLD DURATION (min)
NO.	LOAD DIRECTION	ANCHORAGE SYSTEM	TORQUE (ft-lbs)		
A-1	Side Load (Parallel to Seam)	Nylon Tip	180	3,624	1
A-2				3,696	1
A-3				3,636	1
Average				3,652	1

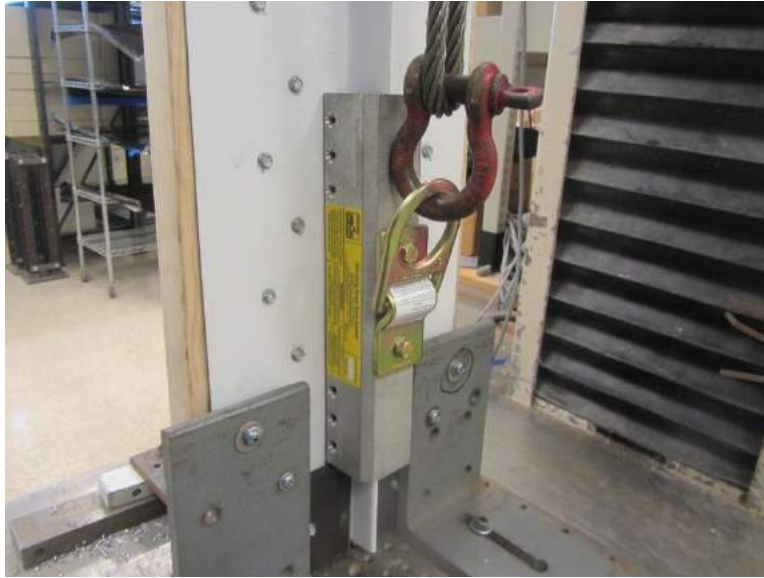
Photo No. 7

OSHA 1901.140(c)(8) Static Load Evaluation - Parallel Load Application Detail

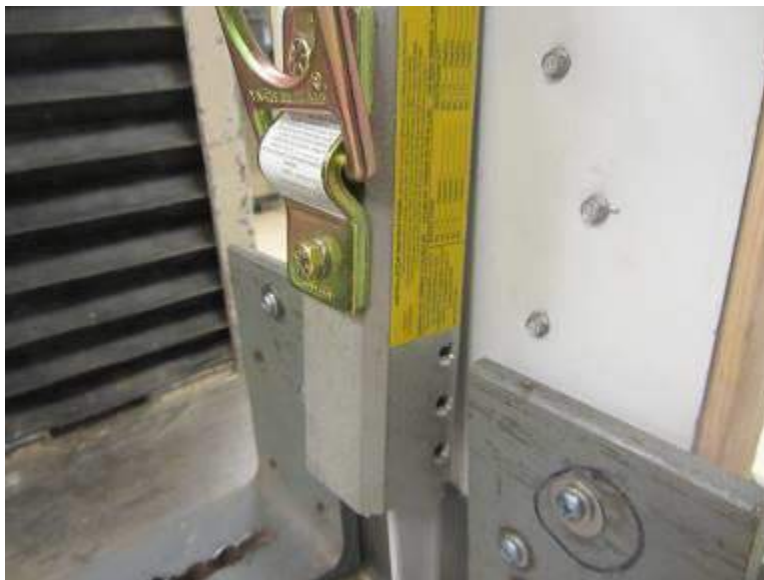
Photo No. 8

OSHA 1901.140(c)(8) Static Load Evaluation - Parallel Load Test End Condition

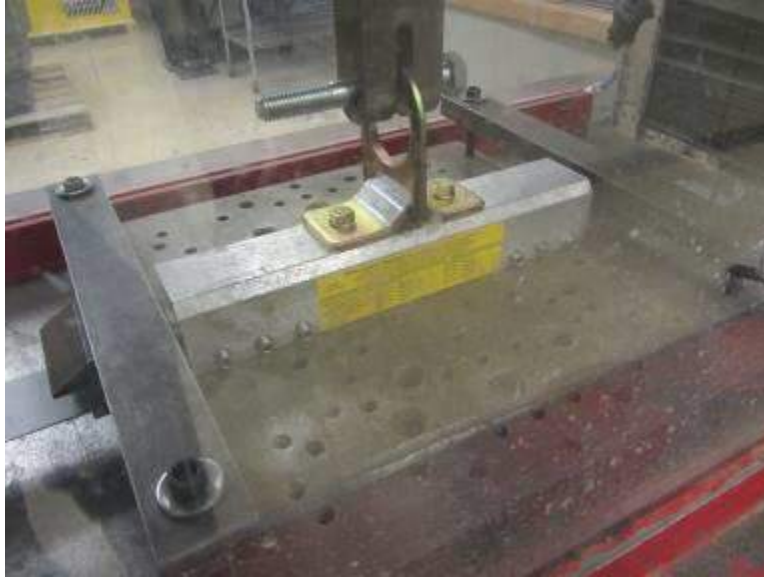
Photo No. 9

OSHA 1901.140(c)(7) Bracket Proof Load/Ultimate Failure Evaluation Test Setup

The Proof Test/Ultimate Failure Load evaluation was performed on a single SSRA1 anchorage assembly restricted to the test stage of a SATEC UTM (ICN: Y002011). Tensile load was applied to the anchorage unit through an integrated D-Ring component at a constant rate of 2 in/min. until failure was observed. Ultimate anchorage failure load was recorded and further evaluated against the performance requirement of minimum 5,000 pounds of force without failure.

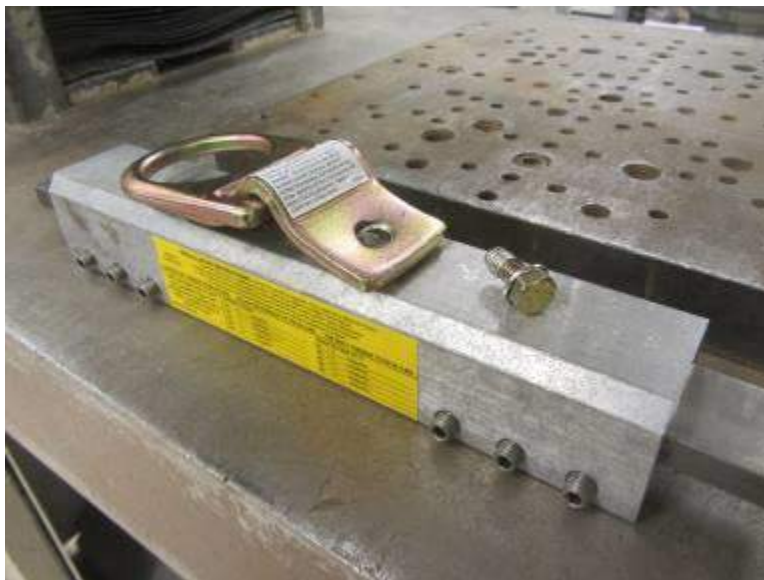
Photo No. 10

OSHA 1901.140(c)(7) - Ultimate Failure Condition

LOAD DIRECTION	ULTIMATE FAILURE LOAD (lb _f)	FAILURE MODE
Direct Tension	14,500	Aluminum Bracket Thread Shear
