Lab Test Report

Fall Protection Distributors LLC
Howie Scarboro

12/12/2014

Received three pieces for Salt Fog testing.

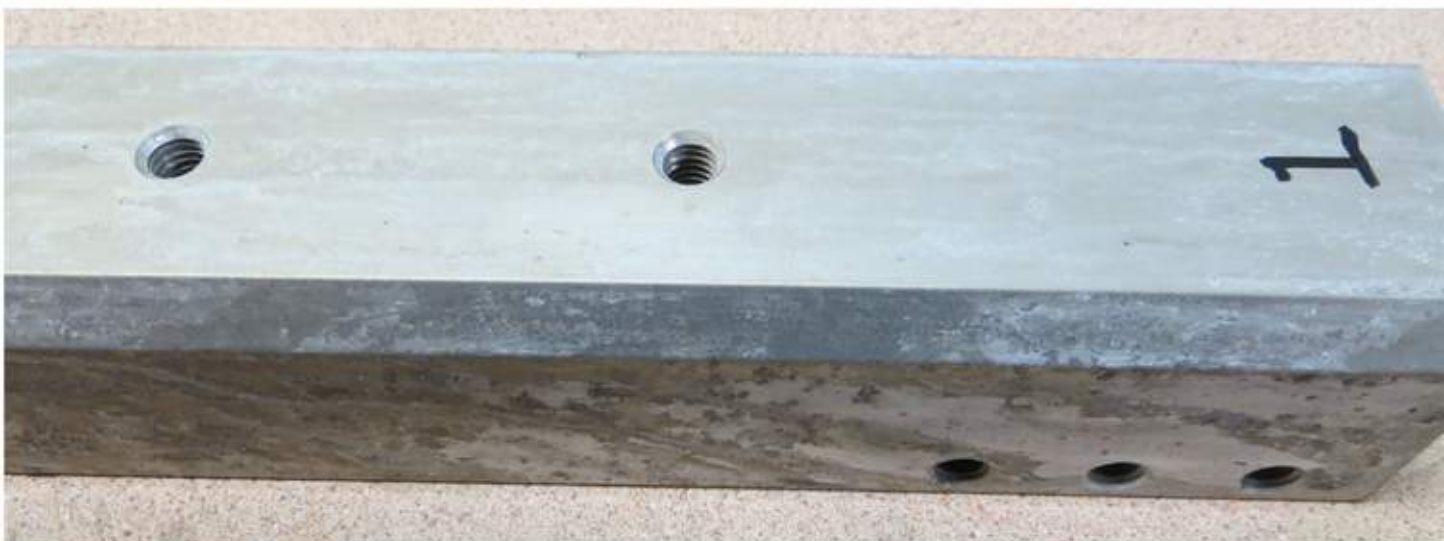
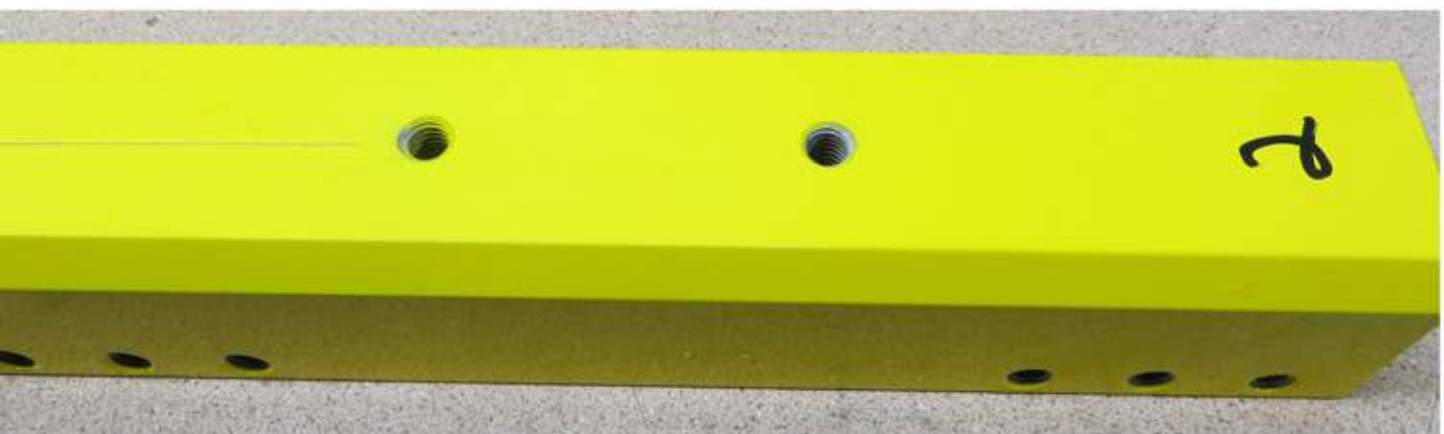
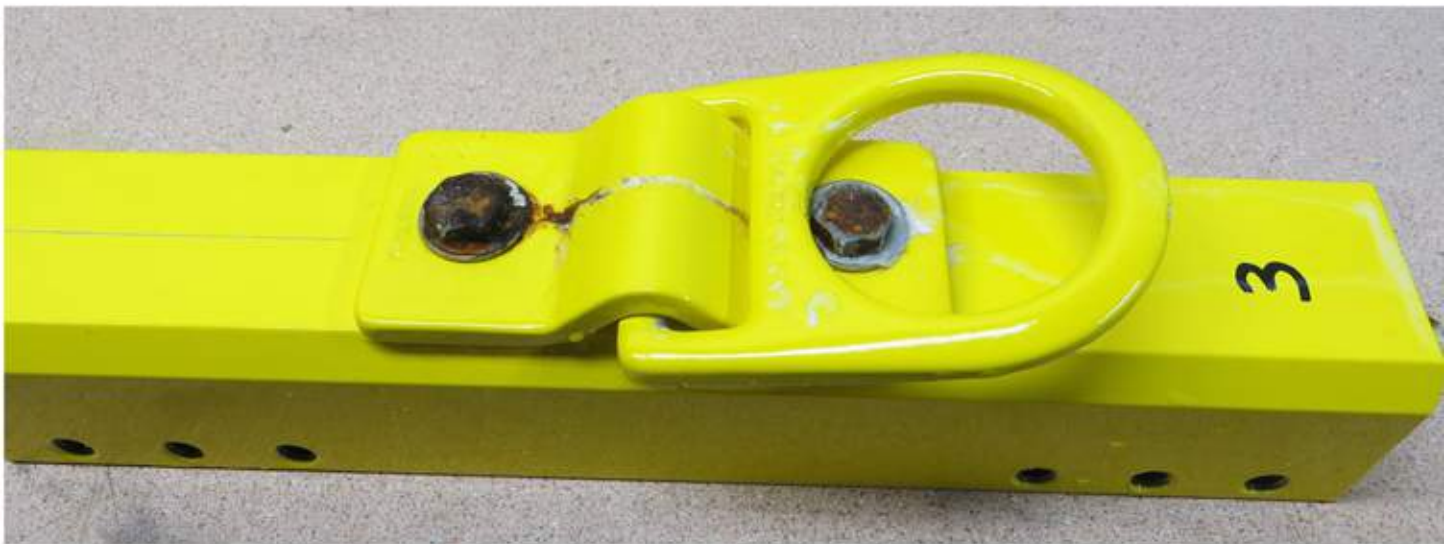
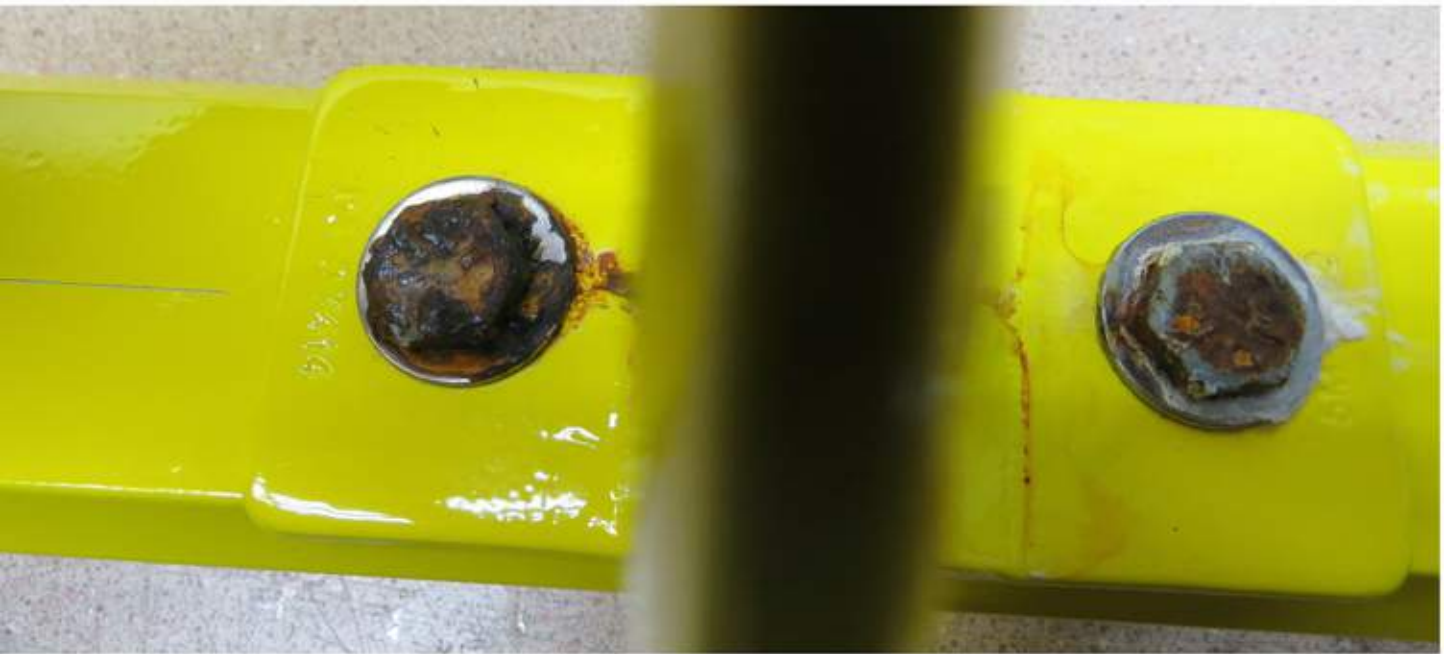
Pc. 1: Bare aluminum was corroded.

Pc. 2: Scribe through powdercoating had no creepage. It looked the same as when it went into testing.

Pc. 3: Scribe through powdercoating had no creepage. The brass ring had no failure. The galvanized bolt heads showed white corrosion and red rust. This is due to zinc galvanizing's inability to protect in an accelerated corrosive environment.
